## A Review of Champion Spark Plug Insulator Cracking Issues In TCM Engines

### Synopsis

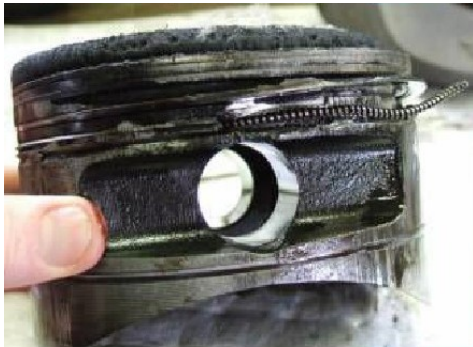
The photo evidence in the MSBs are much more indicative of detonation than pre-ignition. The photographs in the MSBs show a piston that has a pock marked crown, broken ring lands and a scuffed skirt. This is what one would expect from detonation damage; pre ignition would result in a hole melted in the piston and little scuffing or land damage. Below are photos from TATI, Hastings (a well known piston ring maker) and from the Mahle piston damage book. Although it can be difficult at times to discern the difference in detonation and pre-ignition damage because each can occur or cause the other, it is clear from the photo's that the TATI piston is largely detonation damage. The TATI piston shows the pocked crown that is illustrated by Mahle Figure 3.7-1 and scuffed skirt characteristic of detonation damage that is shown in Mahle Figure 1-3. There is little resemblance between the TATI photo and Hastings and Mahle Pre-Ignition Damage photos.

Piston photo from TATI SB11-05

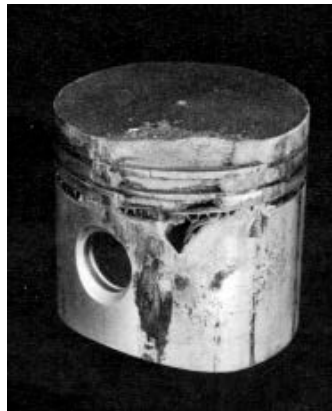
Detonation Damage  
(Hastings)

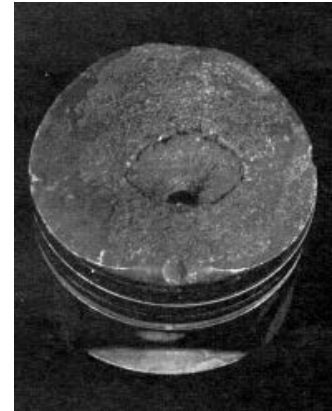
Pre-ignition Damage  
(Hastings)

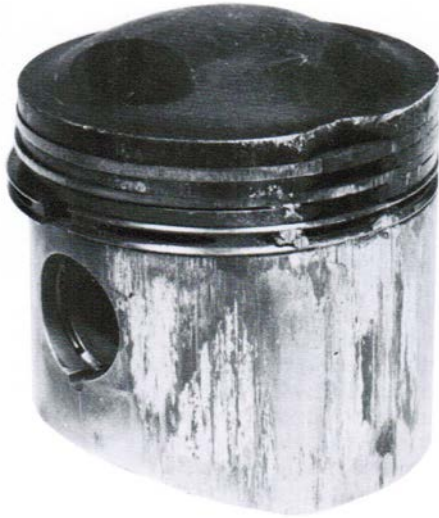
Mahle Fig 1-3 Detonation Damage

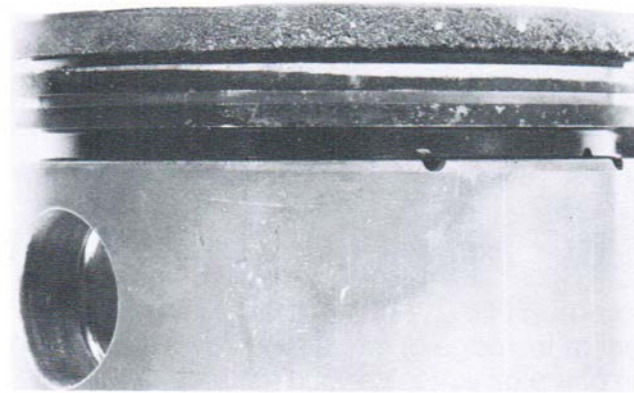
Mahle Fig 3.7-1 Detonation Damage

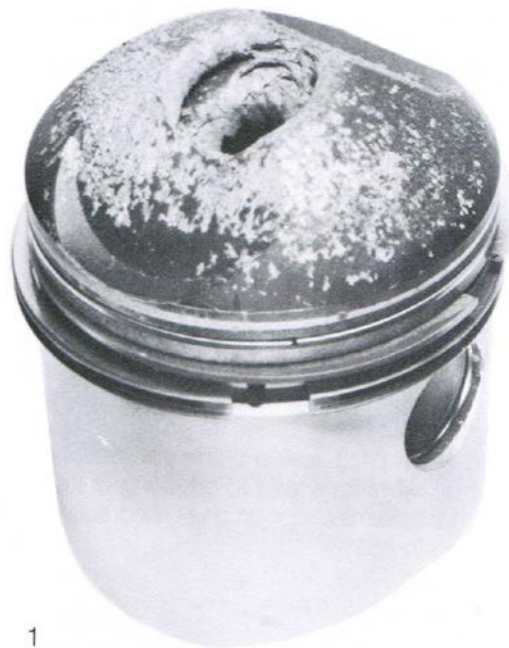
Mahle Figure 3.1-1 Pre-ignition Damage

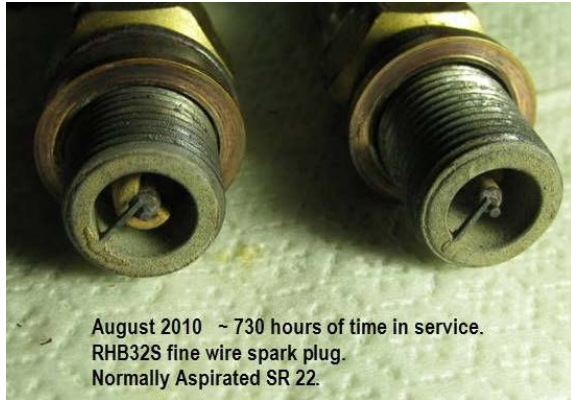
The spark plugs in the MSB photographs also show the characteristics expected from detonation damage, that is; broken insulators. Pre ignition damaged plugs will have the center and ground electrode melted.

August 2010 ~ 730 hours of time in service.  
RHB32S fine wire spark plug.  
Normally Aspirated SR 22.

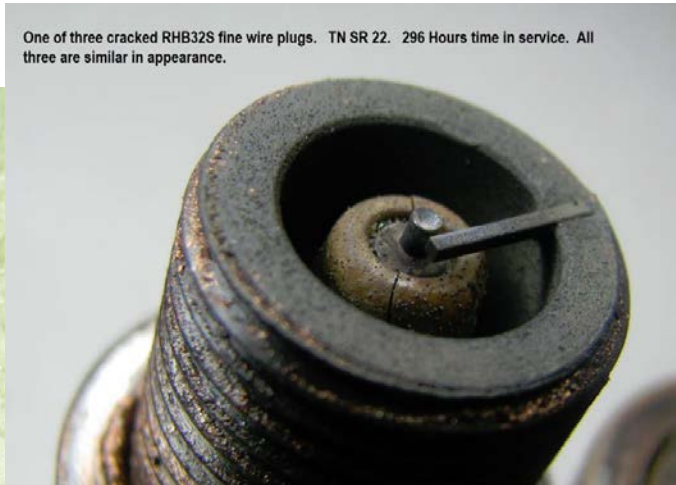
One of three cracked RHB32S fine wire plugs. TN SR 22. 296 Hours time in service. All three are similar in appearance.

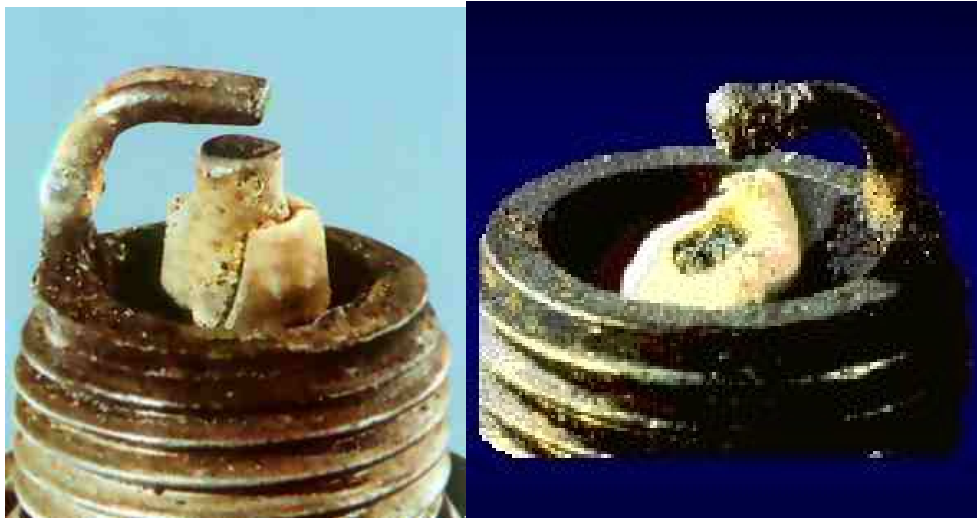
Photos of damaged automotive spark plugs, left plug is detonation, right plug is pre ignition damage. (photo's from Champion)

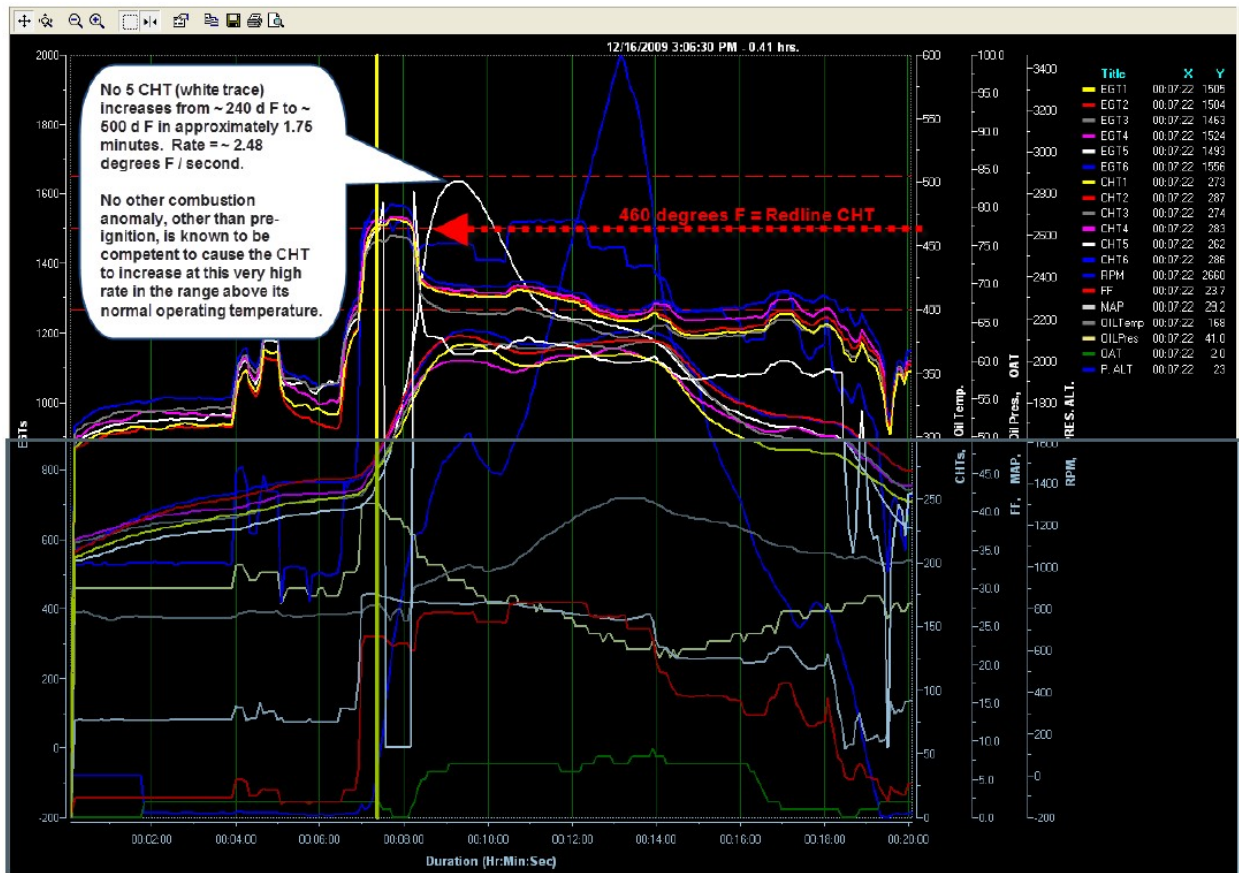
Data Download for NA SR22 from TATI MSB 11-05

So, what is causing the issues resulting in the TATI MSBs? There is good evidence in the data download given in the MSBs that at least the engine of the download was being operated in a condition that reduces the detonation resistance of the engine. The data download given is from a naturally aspirated SR22, again a curious choice for a SB intended for turbo-normalized engines. The MSB download chart is given below. The download shows a fuel flow of approximately 23 gph and assuming that the engine is producing 310 bhp, the specific fuel consumption would be .44 lb/bhp/ hour. This sfc is fairly close to best power and far from the .52 sfc that is the target 27.1 gph fuel flow in the SR22 POH. It is likely that the engine was developing more than 310 bhp since the download shows a pressure altitude of -200 feet and an OAT of less than zero at takeoff when the event occurred. The increased power will be in the range of 10% or 340 bhp, with a resulting sfc of .40 lb/bhp/hr, pretty close to peak EGT and certainly in the operation zone where detonation resistance is lowest. In short, the engine was not operated according to the POH, that it was probably leaned for takeoff, and that it was detonation that caused the cylinder failure.
